Tech-Net Notes

NO: 43-37
DATE: 2-25-2003
MODEL: MY 2001-2002 S60, V70, V70 XC
SUBJECT: Shift Quality Issues due to B4 Servo Cover Failure,
2-3 upshift harshness or flare
CHASSIS: These chassis breaks are approximate:
S60: 062000-152000
V70: 116000-230000
V70 XC: 036000-067100

TRANSMISSION SERIAL NUMBER: The first 3 digits of the serial number on the affected transmissions will be between 01C (March 2001) and 01L (December 2001).

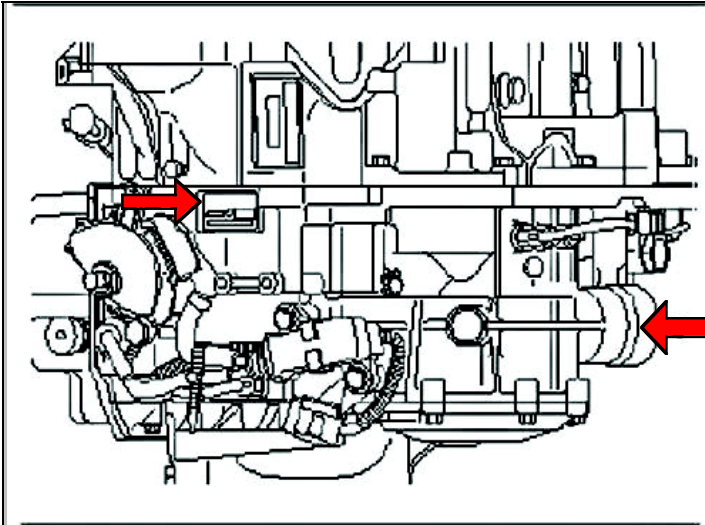
1. Location: This is a top view of the transmission, as seen from under the hood. The B4 cover is located on the rear of the transmission. It faces towards the rear of the car.

The B4 cover and the identification plate, which contains the serial number are highlighted in this drawing.

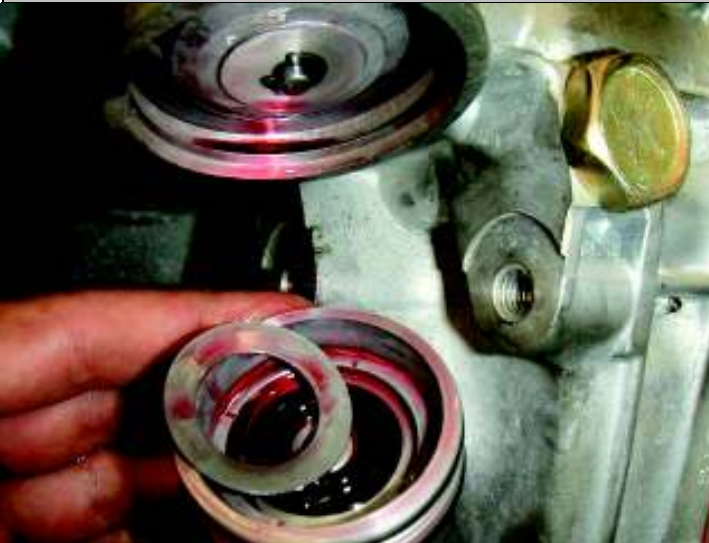
If this washer breaks free from the crimps it will become concaved because of the B4 piston return spring pressure.

- 2-3 upshift flare / slip
- Harsh 2-3 upshifts
- 3-4 upshift flare / slip
- Harsh 4-3 downshifts

8. Remove the servo cover from the transmission. If it is faulty, it will look like the one pictured here. The steel washer will have become separated from the aluminum cover. As pictured here, the piston and spring will usually stay inside the transmission. If the piston begins to slide out, push it back in and it will usually stay in place.

Note: If the steel washer is still firmly attached to the aluminum cover, re-install it according to the rest of the procedure, it is not the cause of the harshness / flare.

Replacing the broken B4 cover with a new one (PN 30651771) will remedy these symptoms.
